SAFETY IN THE MR LINEAR ACCELERATOR DEPARTMENT

AN INCIDENT WITH MR UNSAFE EQUIPMENT

ANAESTHESIA, SEDATION AND NEED FOR VIGILANCE

IMPROVING MR SAFETY FOR NEUROMODULATION

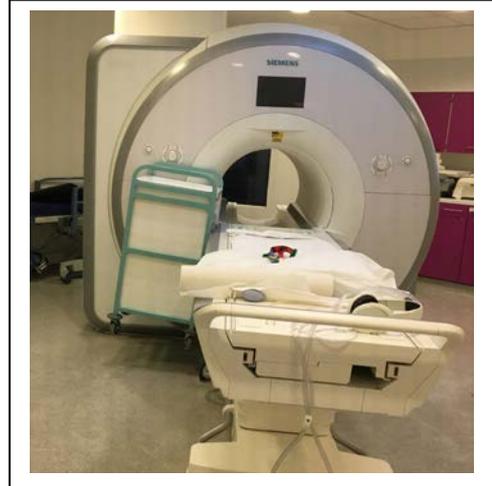
An MR Unsafe trolley was brought into the MR environment by a highly experienced MRI radiographer. This happened in the period between examinations when the room was otherwise empty. The error was noticed immediately, as the trolley was pulled towards the 3T magnet. The radiographer tried to hold back the trolley and got his hand trapped momentarily between couch and trolley, resulting in very minor injury

The MRI manufacturer was contacted to ramp down the field and remove the trolley – this happened the next day. All appointments for that day were cancelled.

Labelling: The MR Unsafe trolley was appropriately labelled. However, the label could be hidden by items on top of the trolley. When in use, the attention is drawn to items on the trolley, and the trolley in itself is not the focus. **The labelling was changed and is now much larger, on all sides of the trolley.**

Trolley location: The MR Conditional trolley had been moved outside the MR environment and was not in its usual place - this may have contributed to this accident. **The probability of having accidents is smaller if the MR conditional trolley is always the first one to be found and always in the same place.** Aren't we all "creatures of habit" to some extent?

The way the translating services are managed within the MR controlled access area were changed.

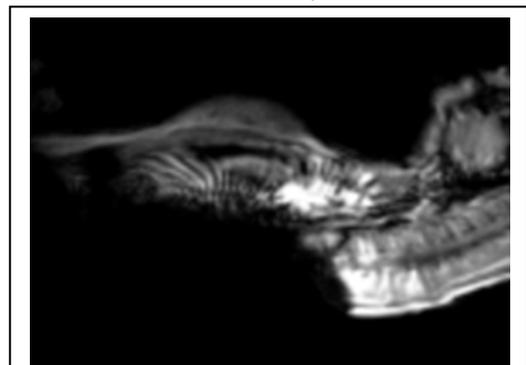
The patient's back brace, which contained some metallic bolts and buckles, had not been noticed prior to entering the MR environment. It was discovered when the localiser sequence showed a substantial susceptibility artefact (Figure 1). The radiographer immediately entered the MR environment and moved the patient out of the bore to check what was causing the artefact, discovering the back brace.

While removing the brace, the radiographer inadvertently knocked and broke the connection between the infusion pump and the patient. Scanning was resumed, but it was noticed shortly after that the patient was beginning to wake and start moving, requiring the anaesthetic team to quickly enter the MR environment and remedy the situation.

Figure 1. Localiser image of the sedated patient, showing the substantial image artefact caused by the metallic bolts and buckles in the patient's back brace.

The MR unit has since improved the level of MR safety training that can be accessed by members of the anaesthetic teams and introduced a final 'pause and check' procedure before any sedated patient enters the MR environment.
